**ELECTRONICS COORDINATING OF**  
**SHIP PREPARATION**  
**and**  
**TARGET INSPECTION**

**FINAL REPORT**  
**TESTS ABLE AND BAKER**

**VOLUME 2**  
**PHOTOGRAPHIC RECORD**

**DIRECTOR OF SHIP MATERIAL**  
**JOINT TASK FORCE ONE**  
**OPERATION CROSSROADS**

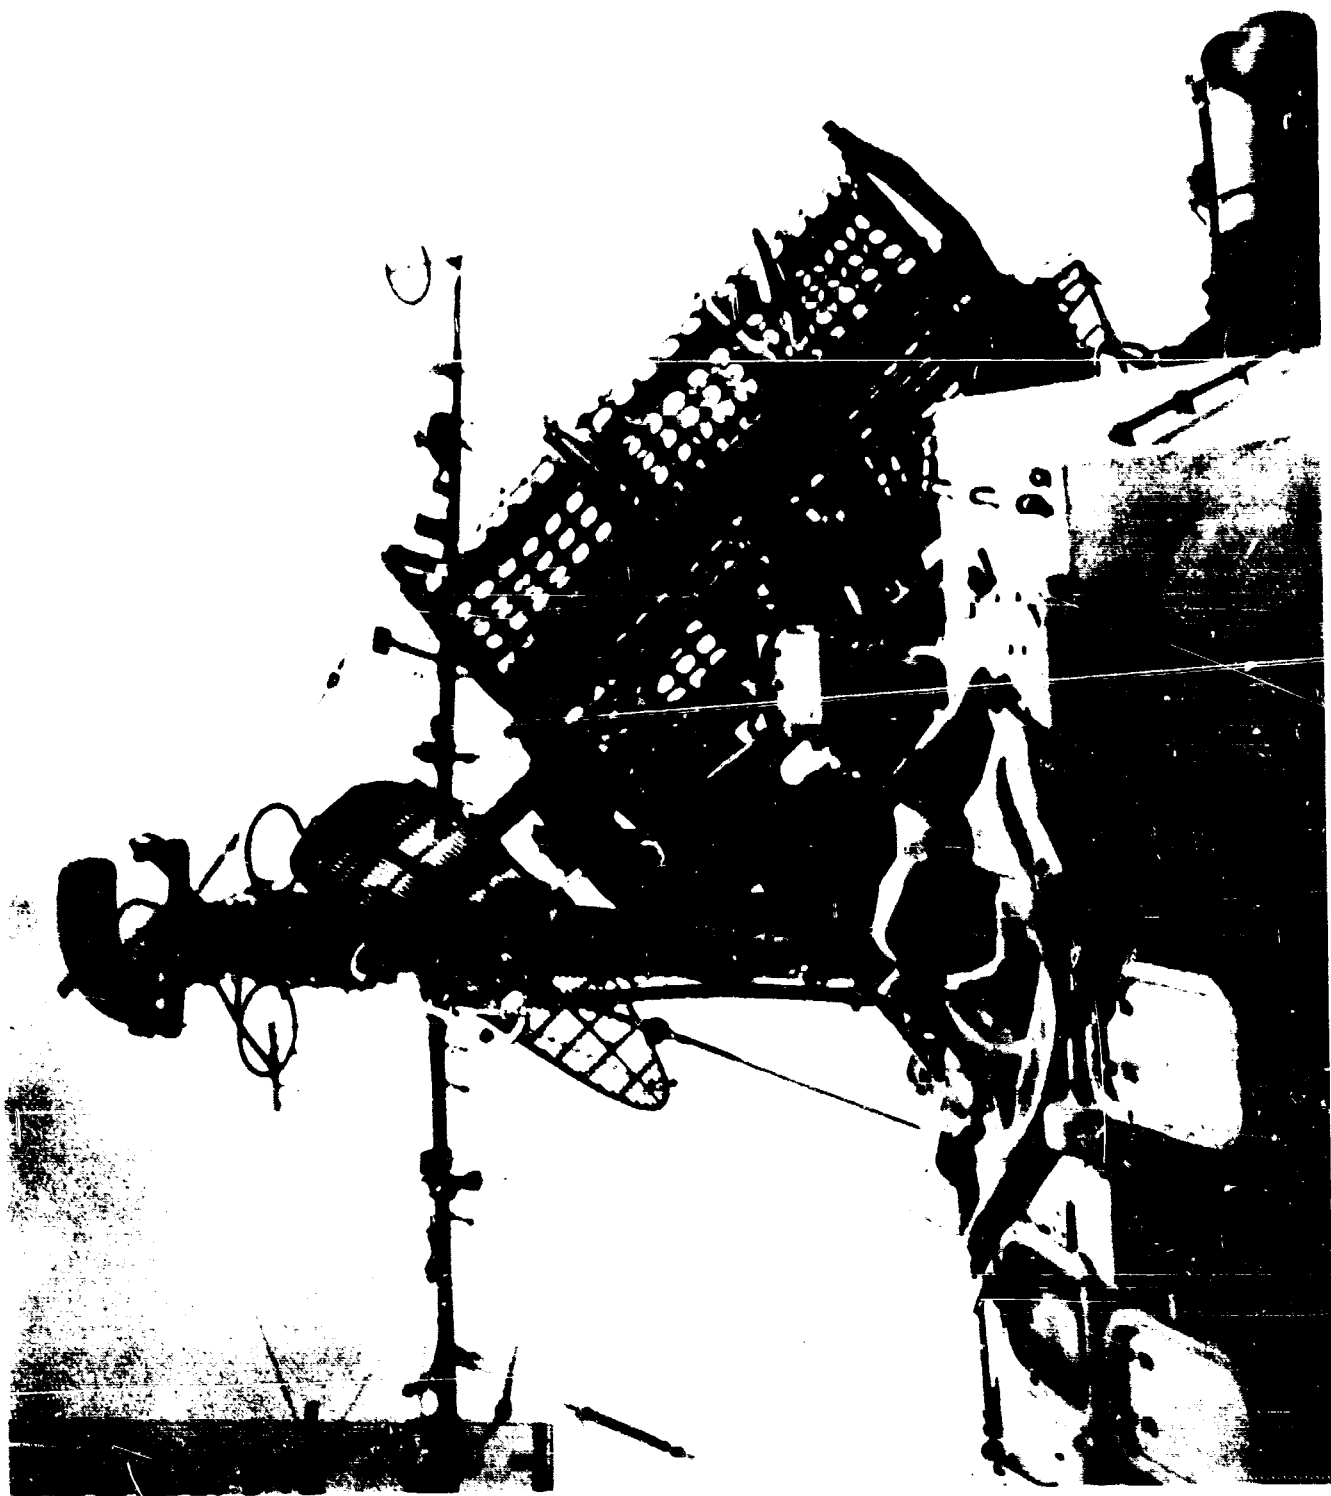
POST BAKER - MK 4 RADAR ANTENNA. MK 4 antenna was knocked over.

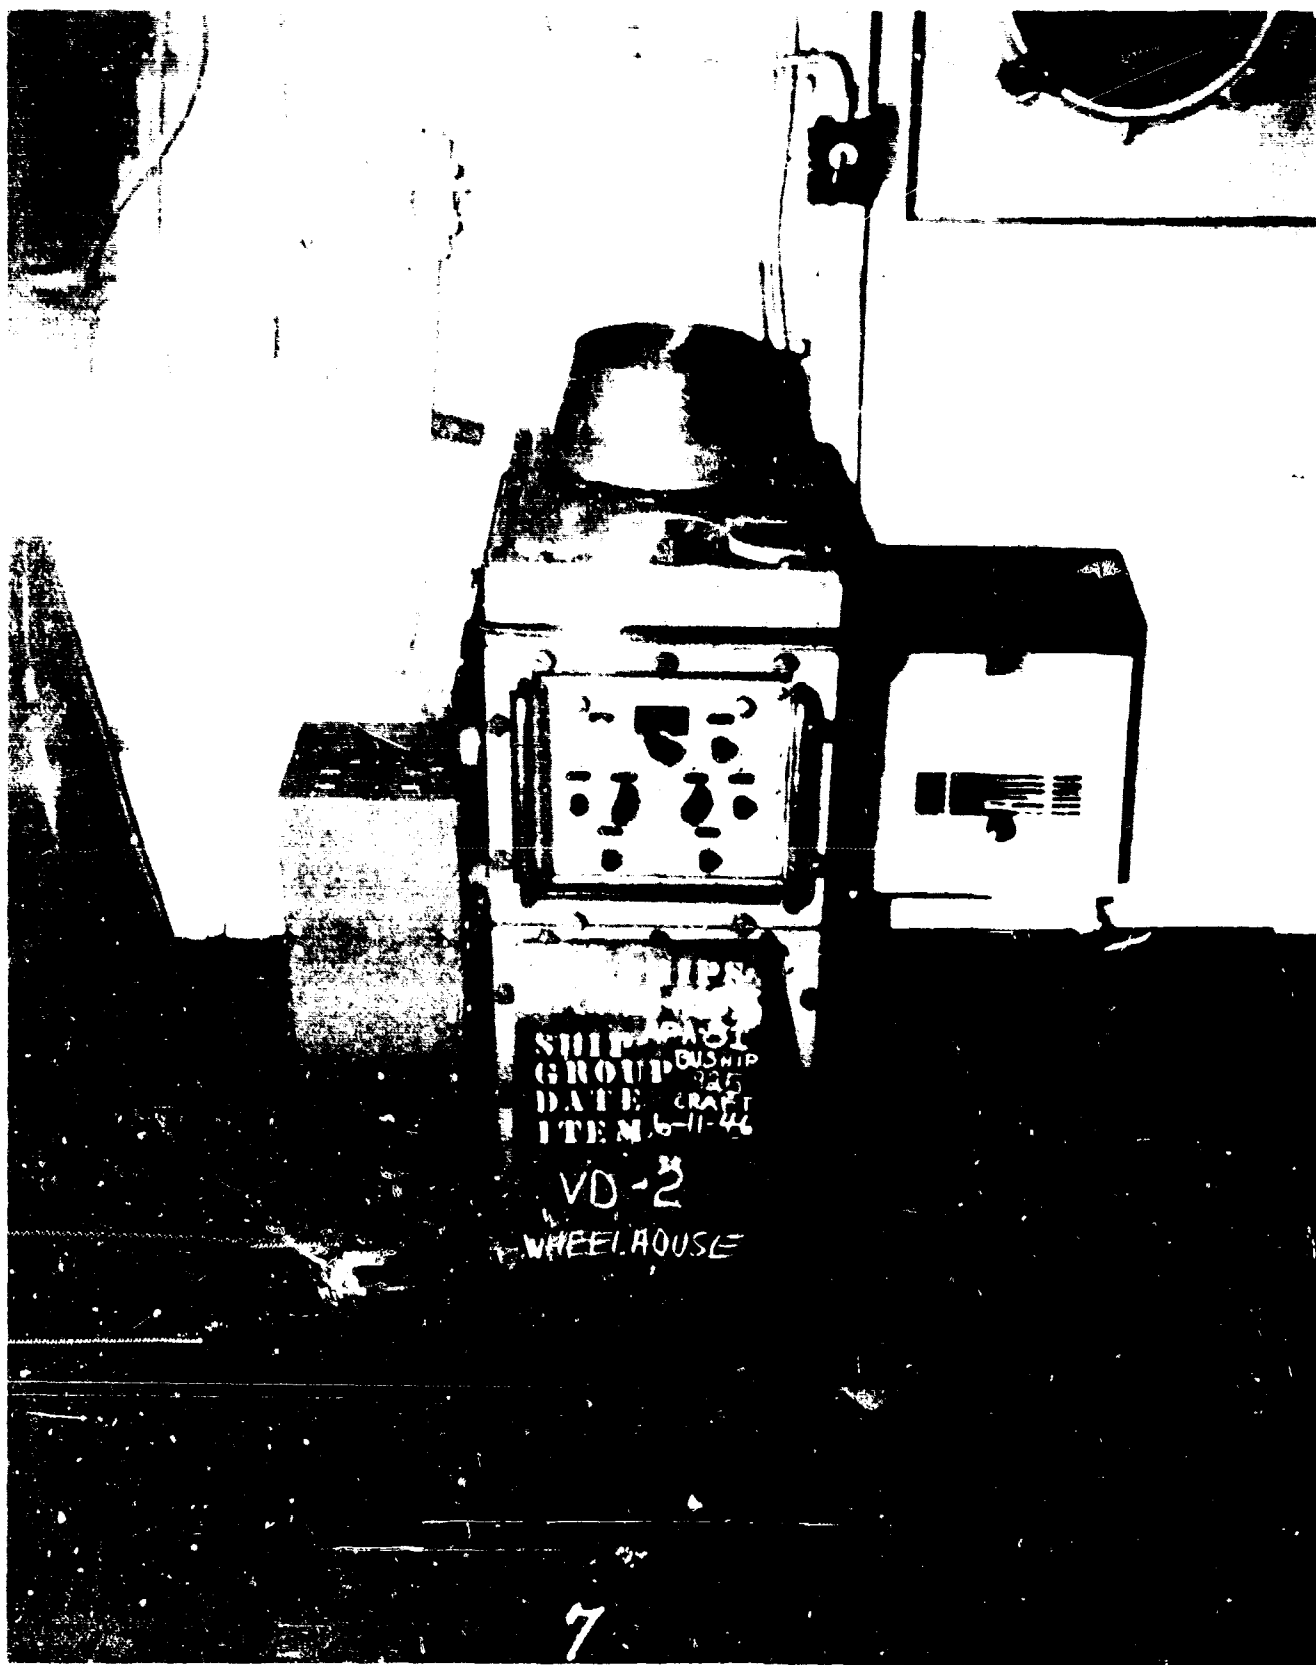
PRE BAKER - VD-2 FRONT VIEW. This equipment was undamaged during Test Able.

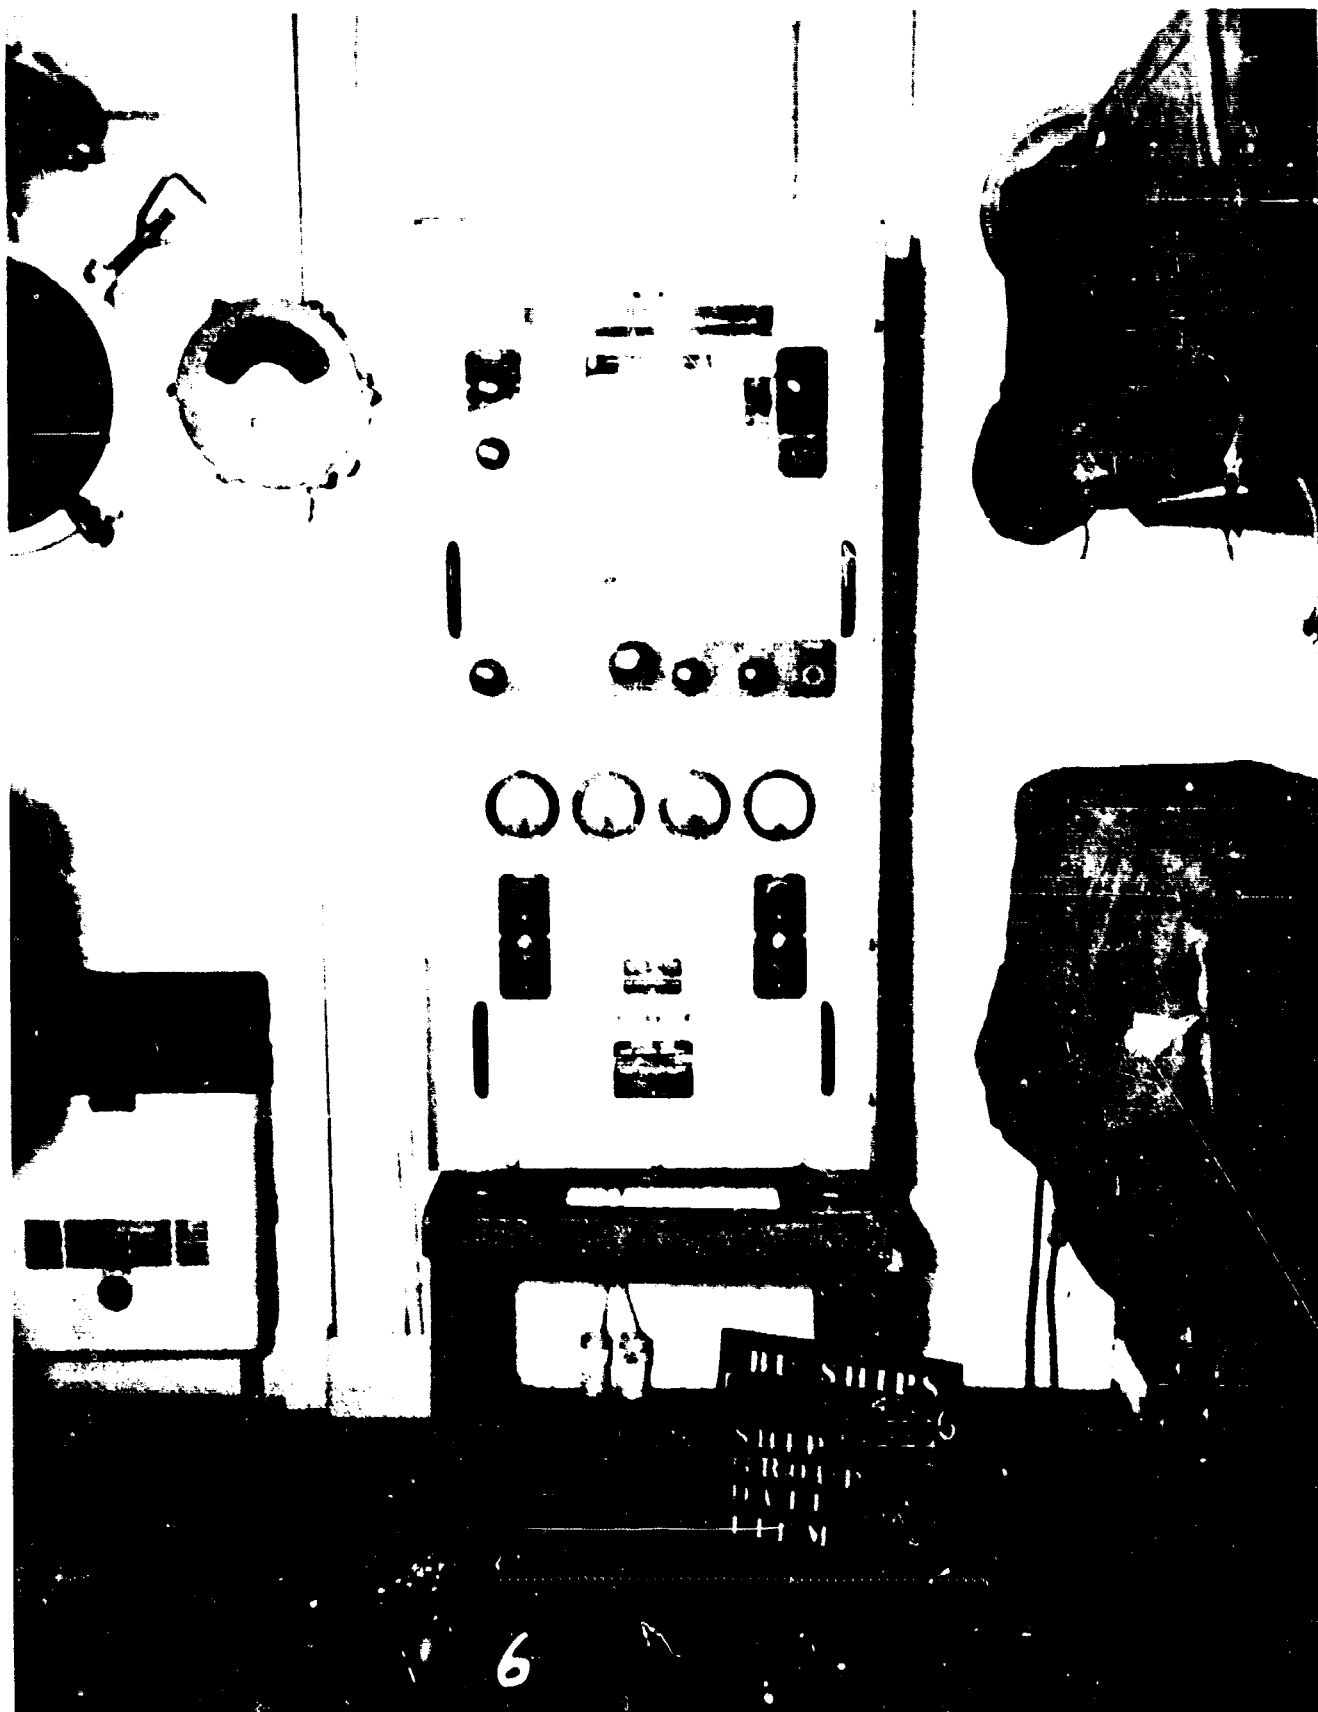
PRE BAKER - NMC AND SCR-608. NMC in pilot-house with SCR-608's at right under canvas covers. This equipment was undamaged during Test Able.

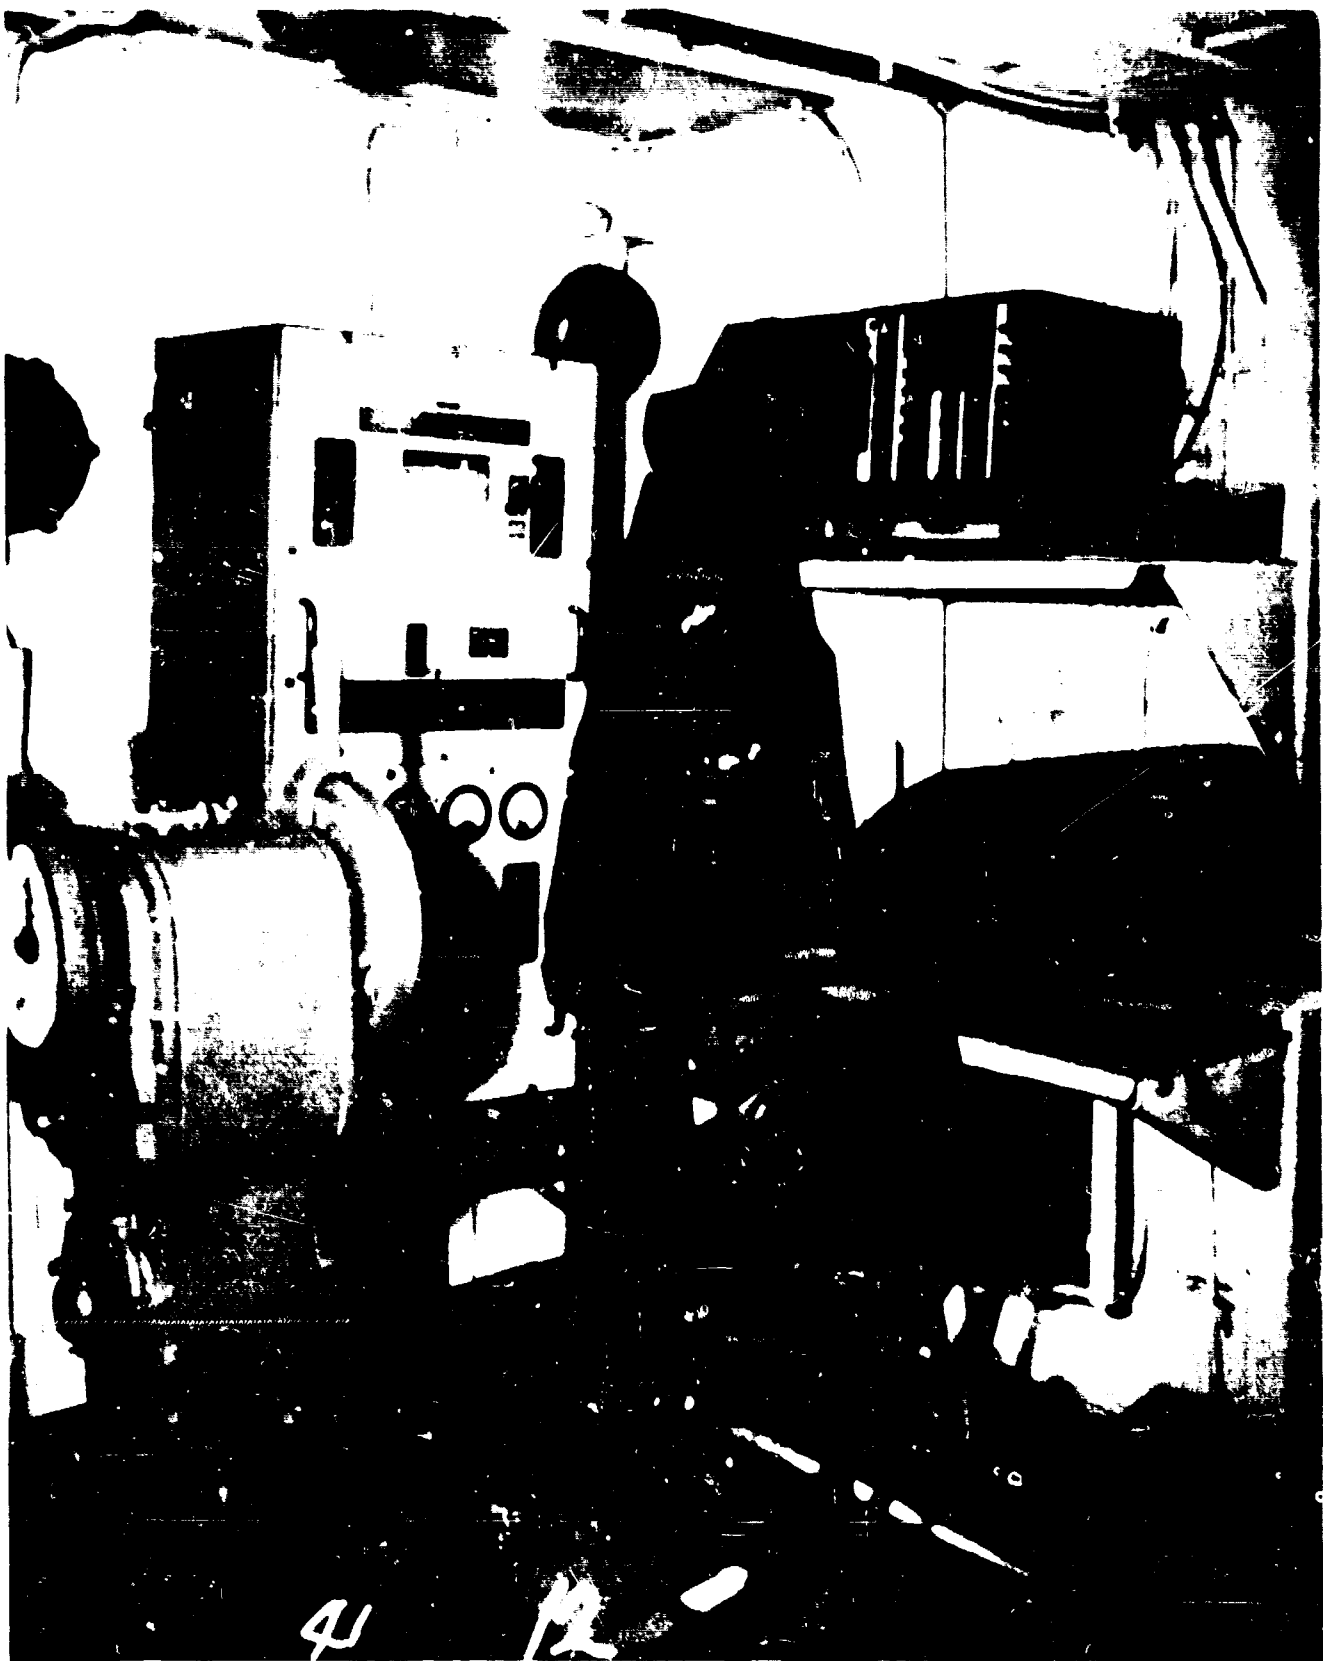
POST BAKER - NMC AND SCR-608. The NMC foundation warped, tilting equipment away from bulkhead. The SCR-608's were partially thrown from their foundations.

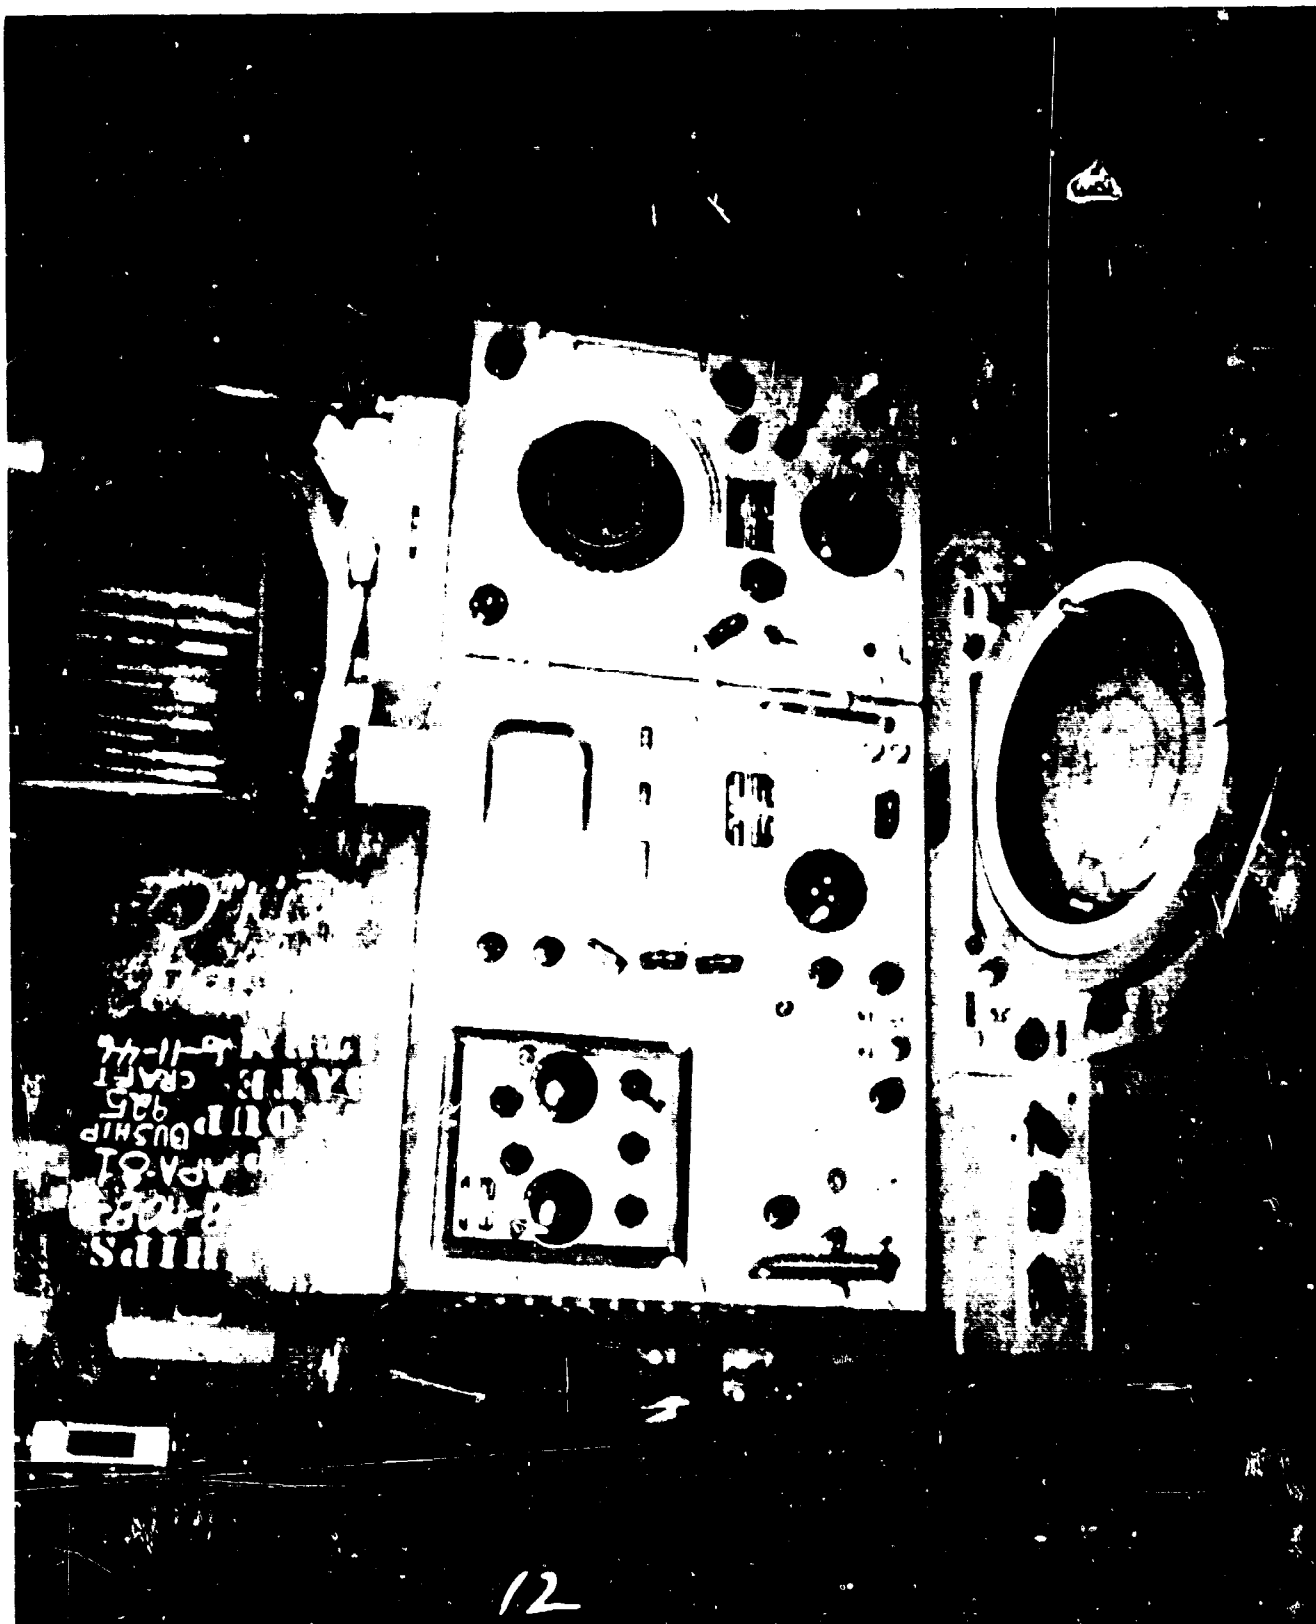
PRE BAKER - SC-4 INDICATOR FRONT VIEW. This equipment was undamaged during Test Able.

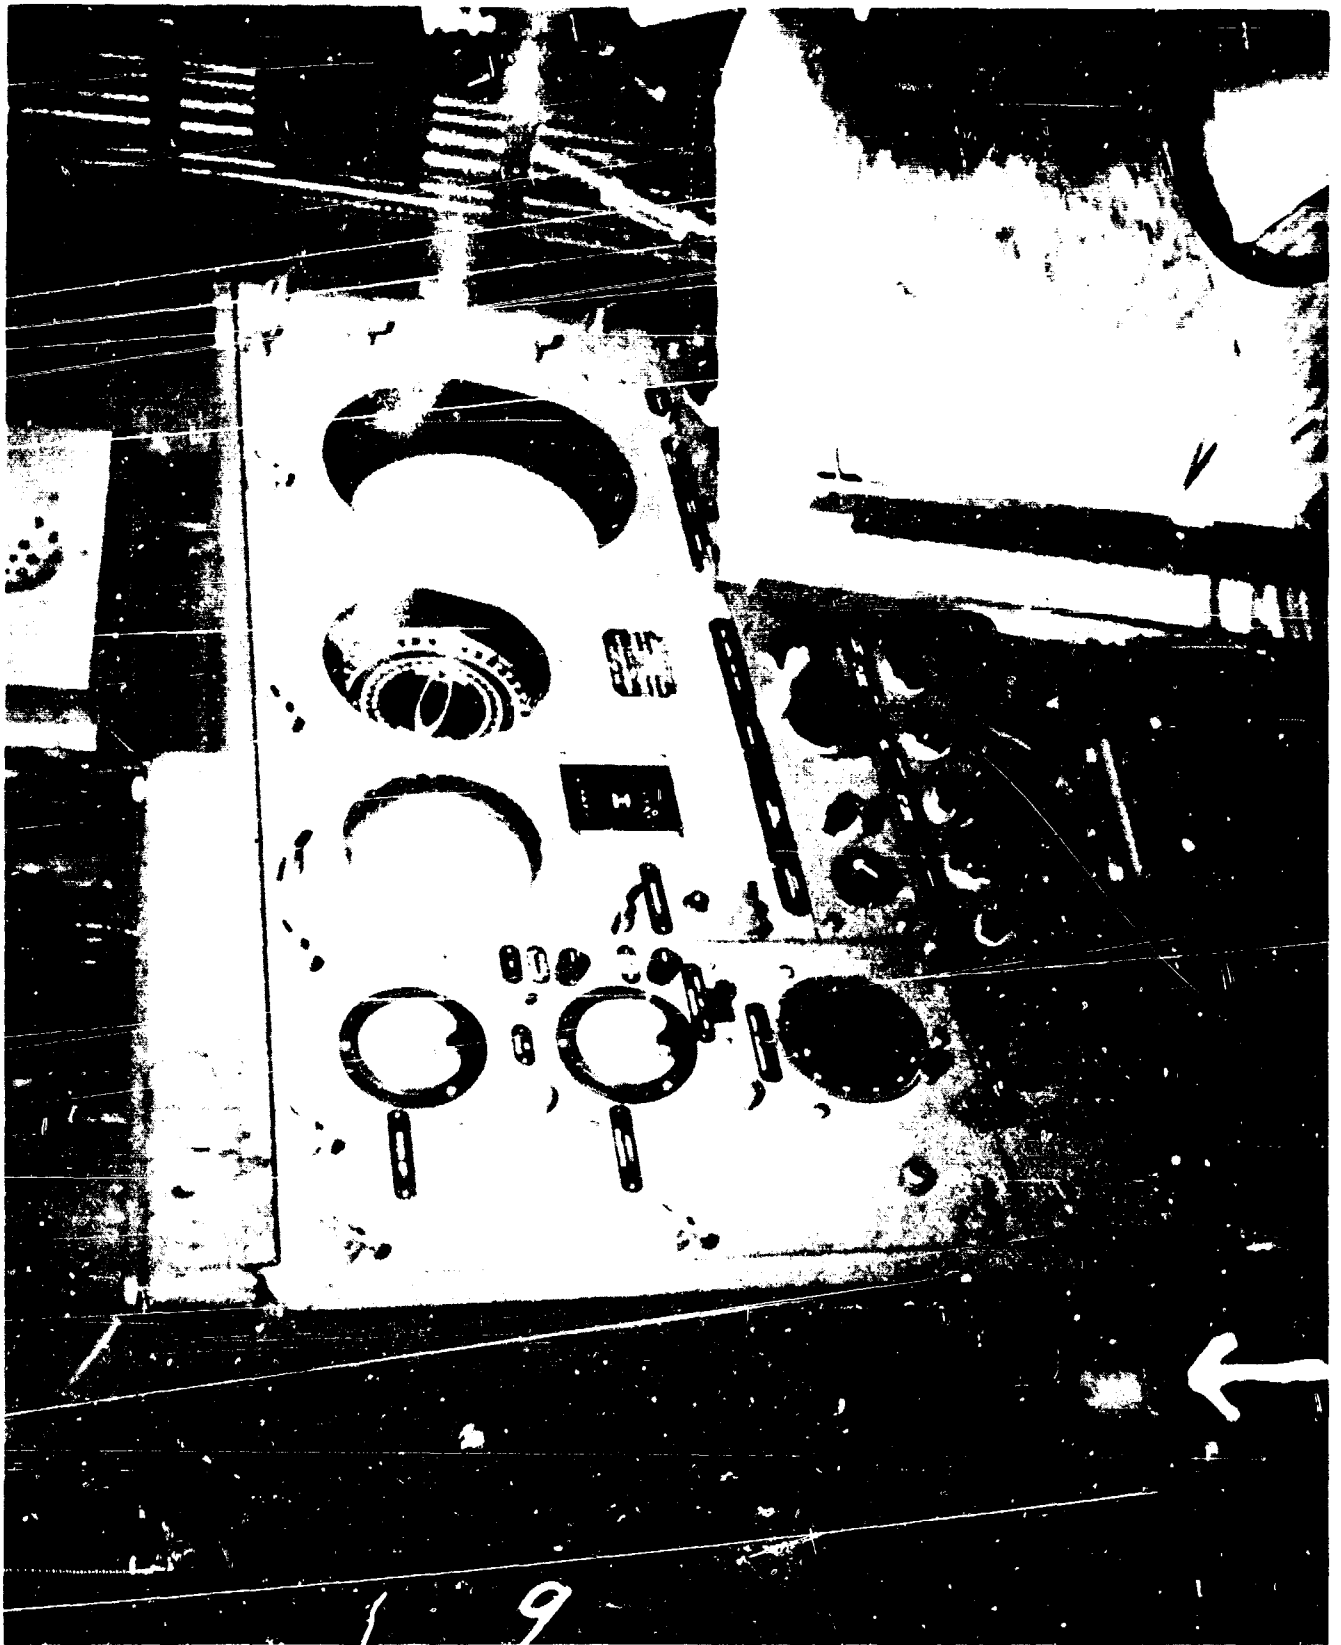
POST BAKER - SG-1 INDICATOR. This was the only equipment of its type in which the shock mount failed. The arrow points to center row of shock mounts. No other damage to indicator was noted.

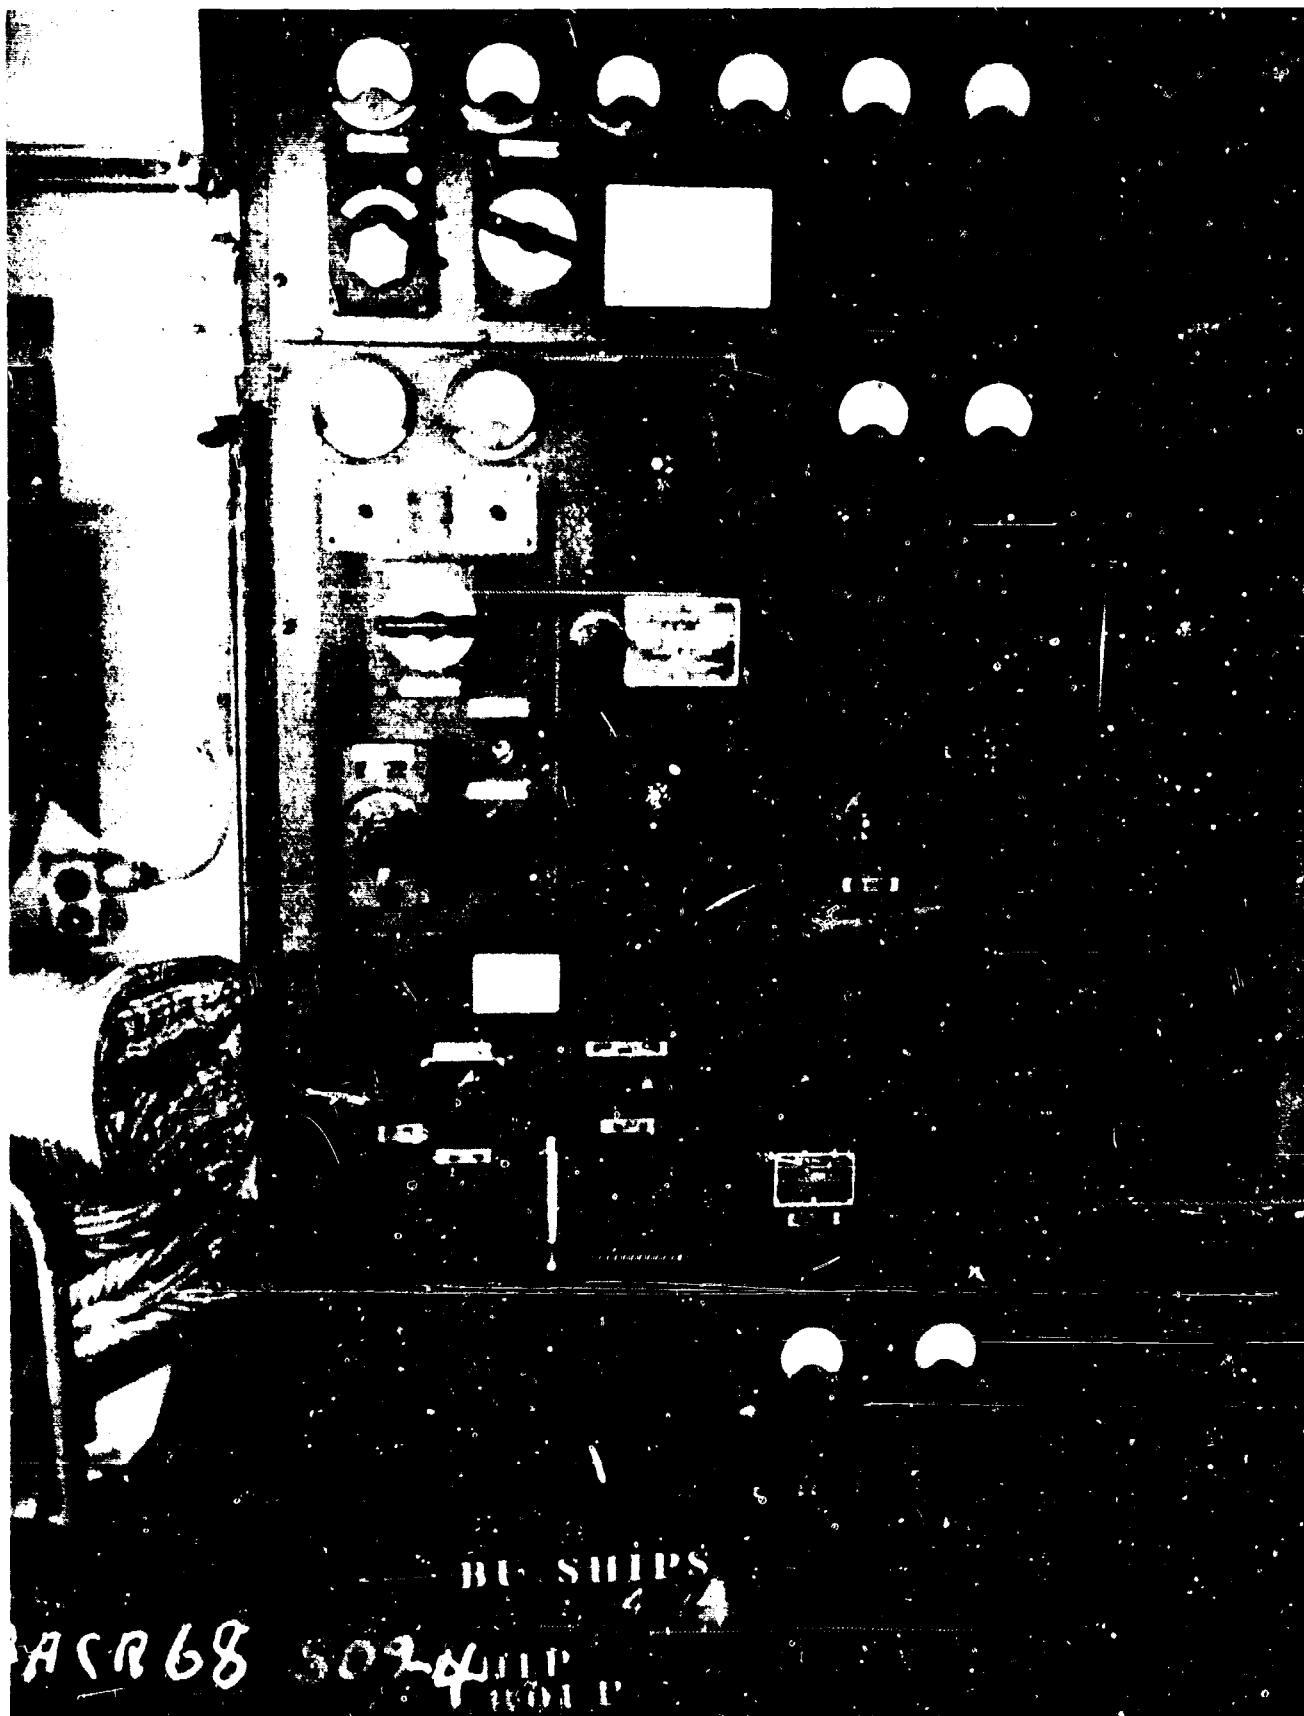
PRE BAKER - TBK-17. Front view. This equipment was undamaged during Test Able.

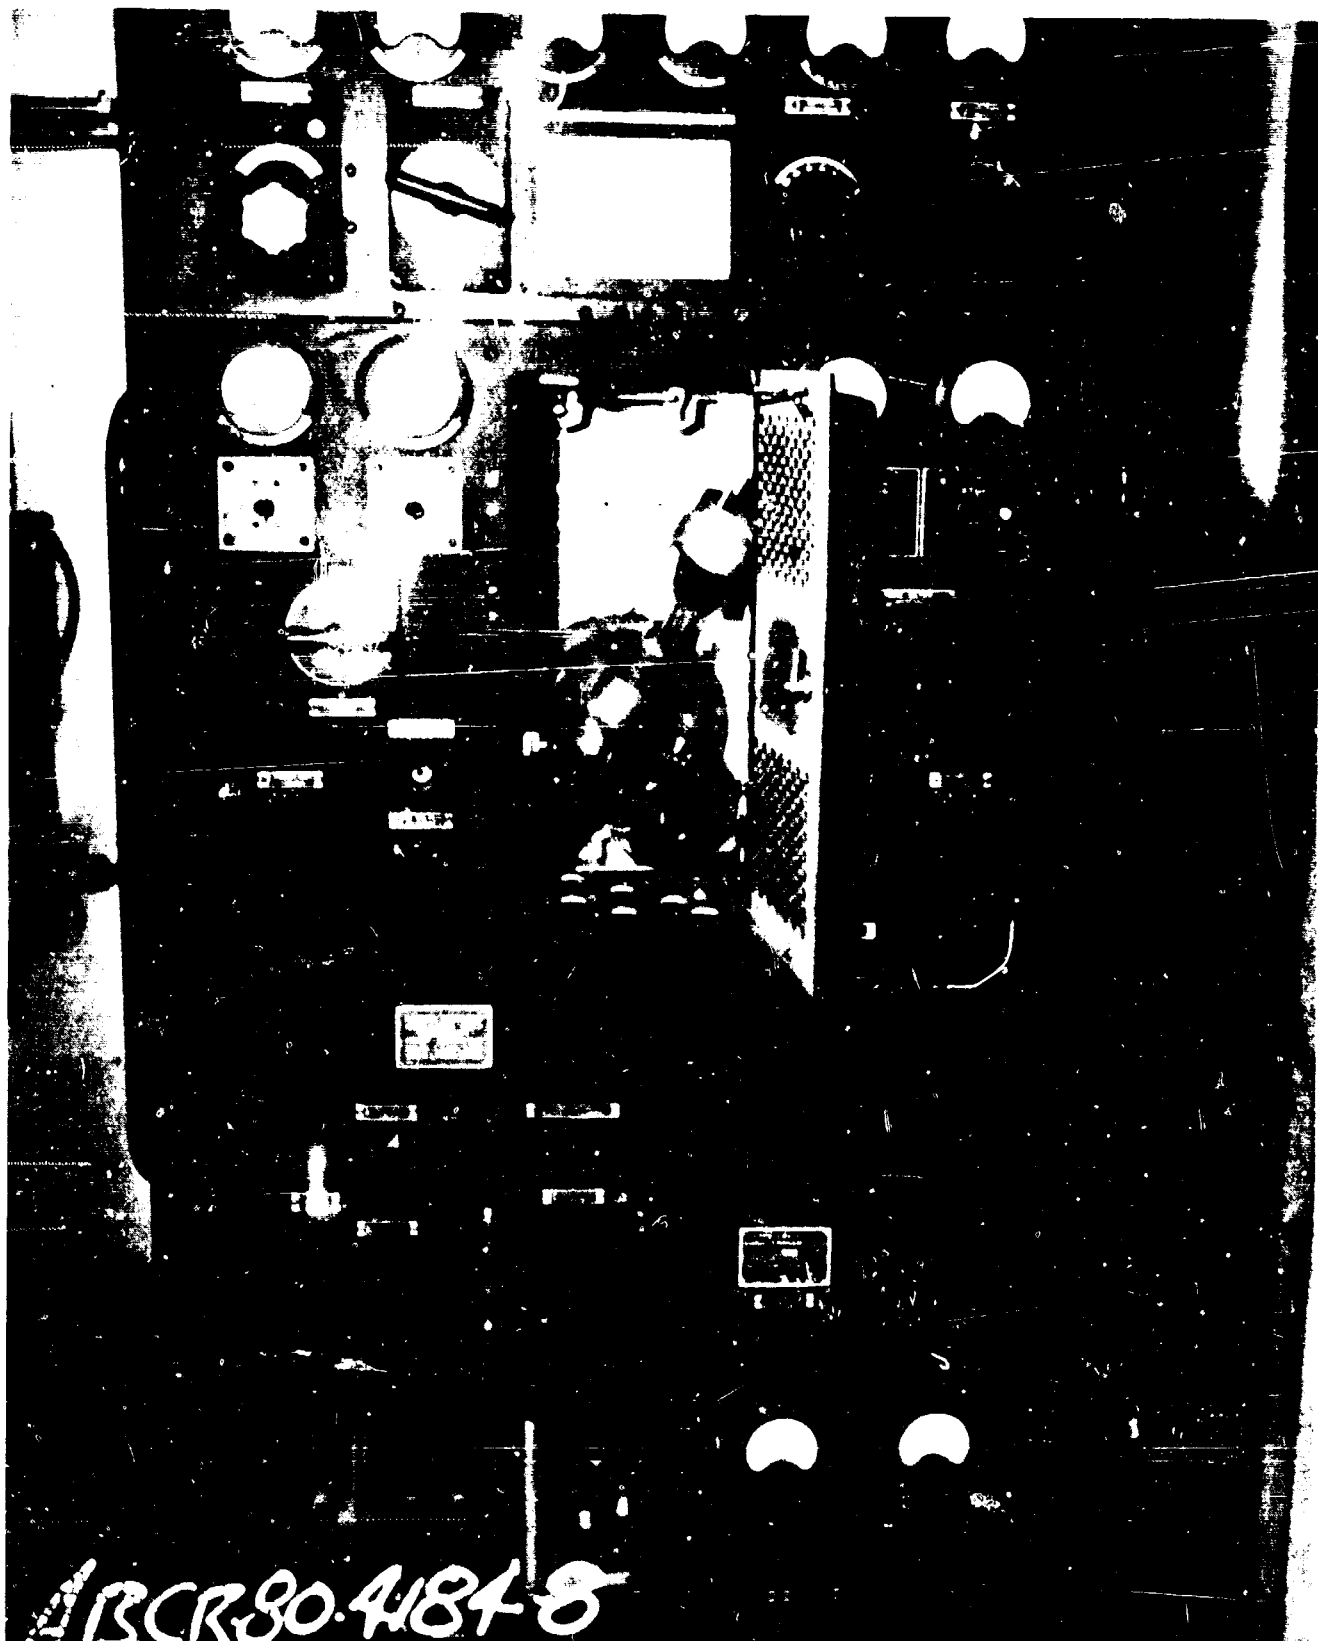
POST BAKER - TBK-17. PA tube was shaken from its mounting clips.

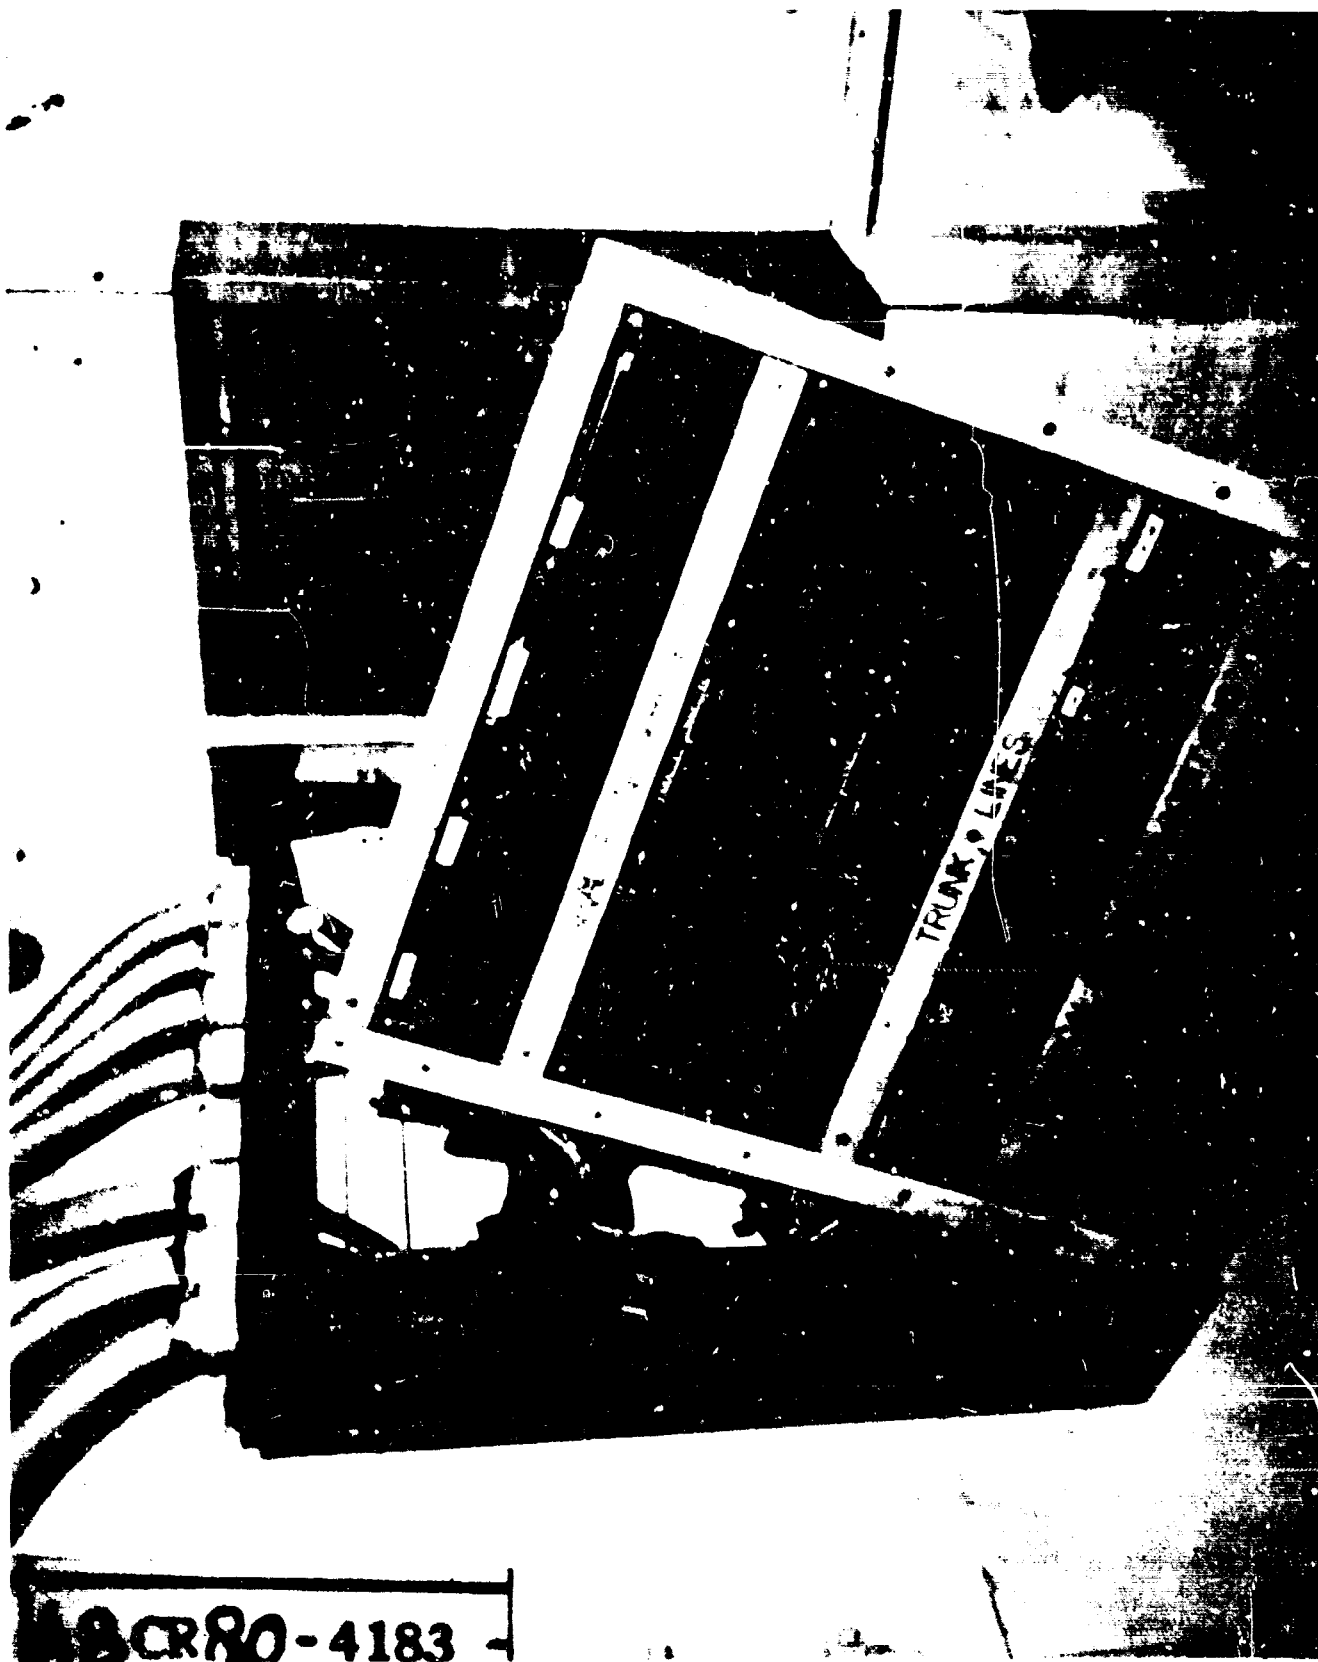
POST BAKER - RADIO I. Radiophone transfer panel. Door was thrown open, ripping off upper hinge, and left hanging on cables in this position. At right is corner of TAJ-19.

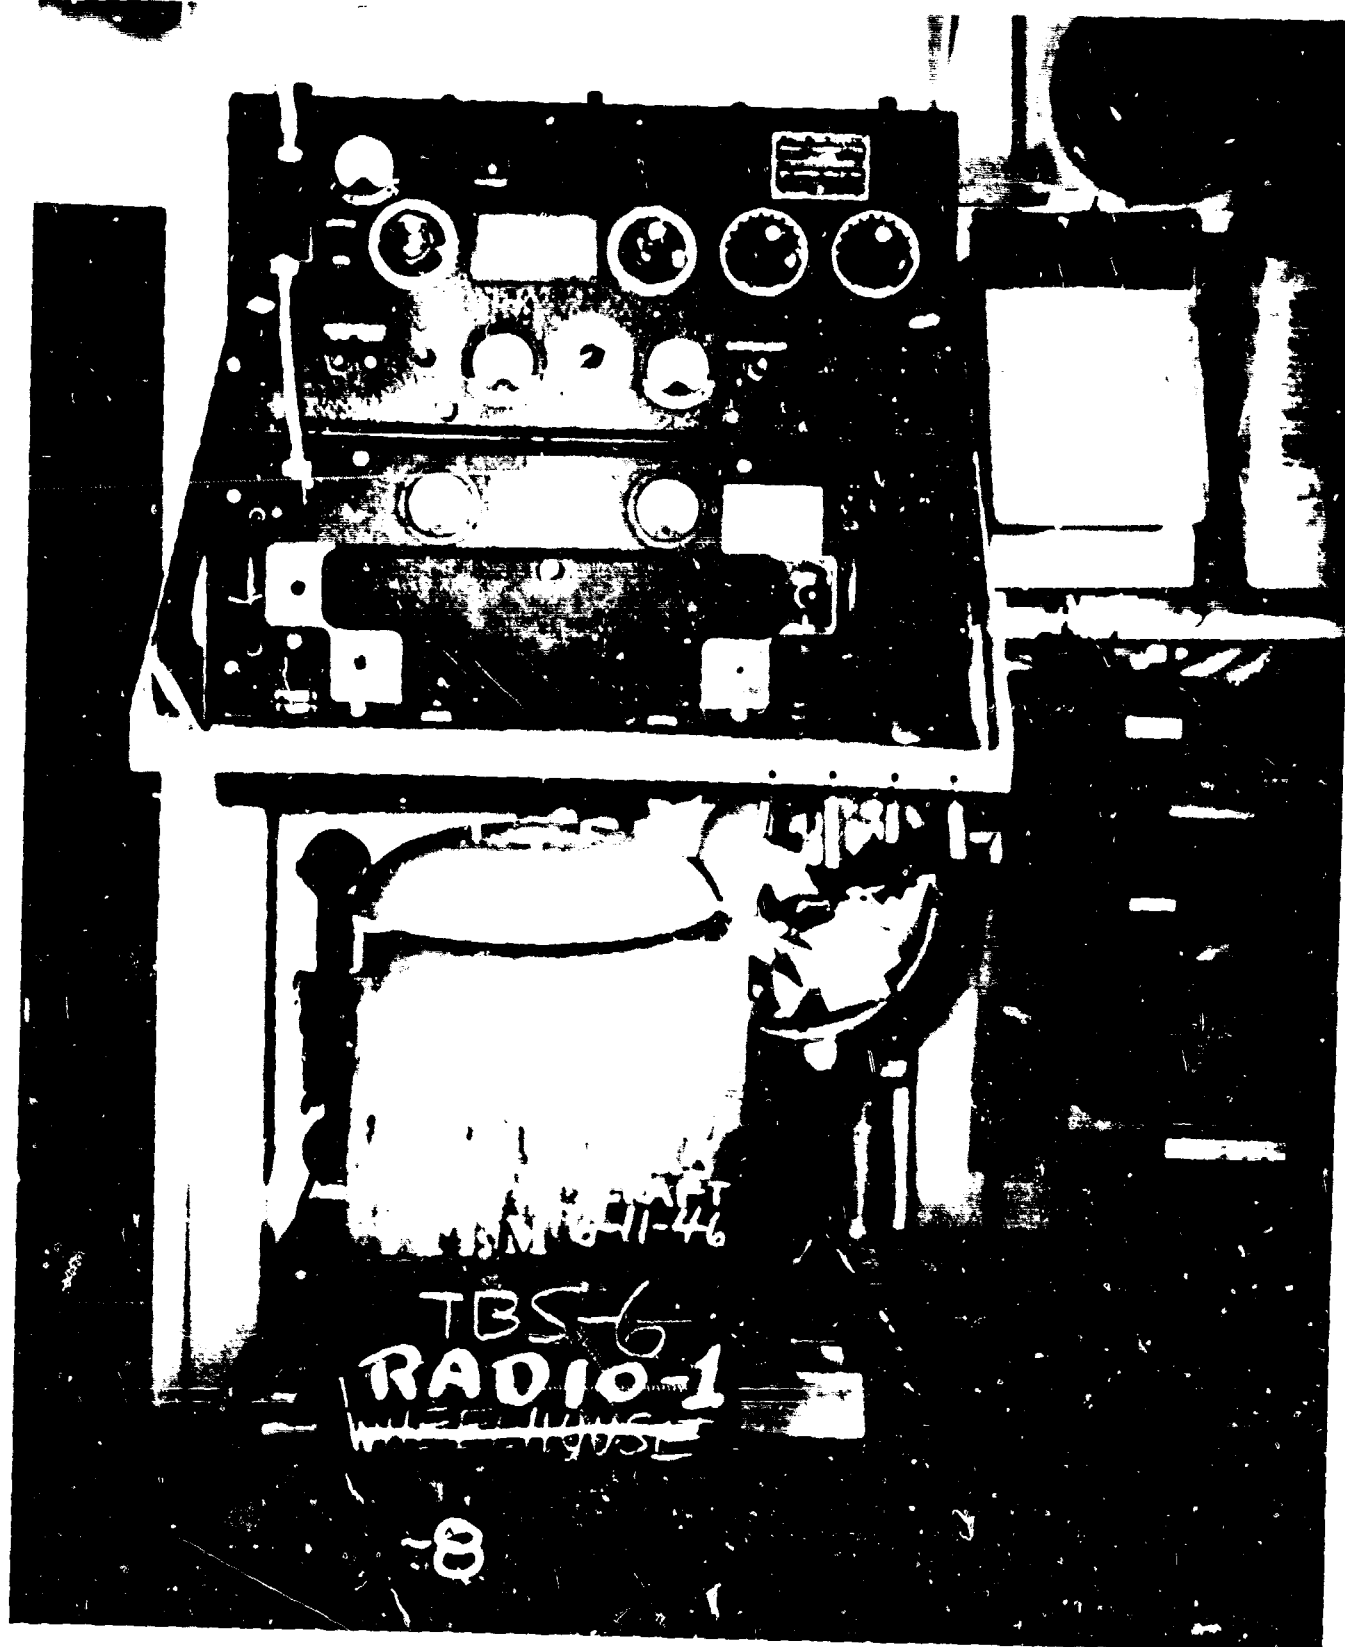
PRE BAKER - RADIO I. View of TBS-6. This equipment was undamaged during Test Able.
